Tipton Vale River Erosion

Feasibility Report

Client: EAST DEVON DISTRICT COUNCIL

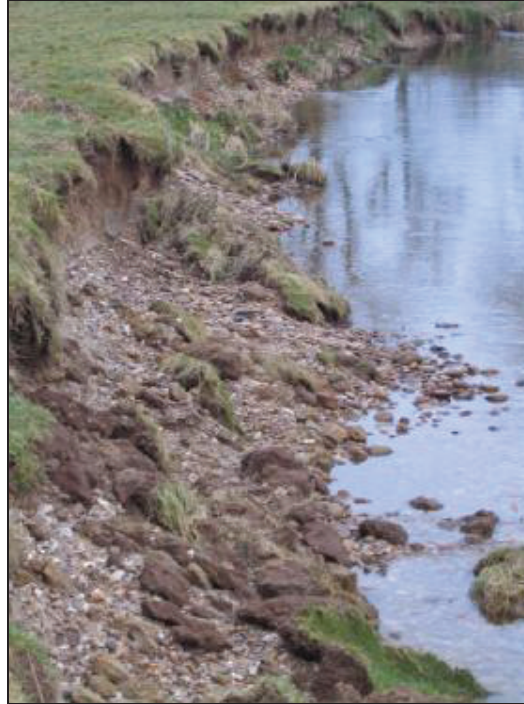
Figure 2-1 Typical Bank Profile

The site comprises 130m of river bank as indicated on Drawing 8041/03. It is currently eroded and is up to 2m high; a typical view is shown in Figure 2-1.

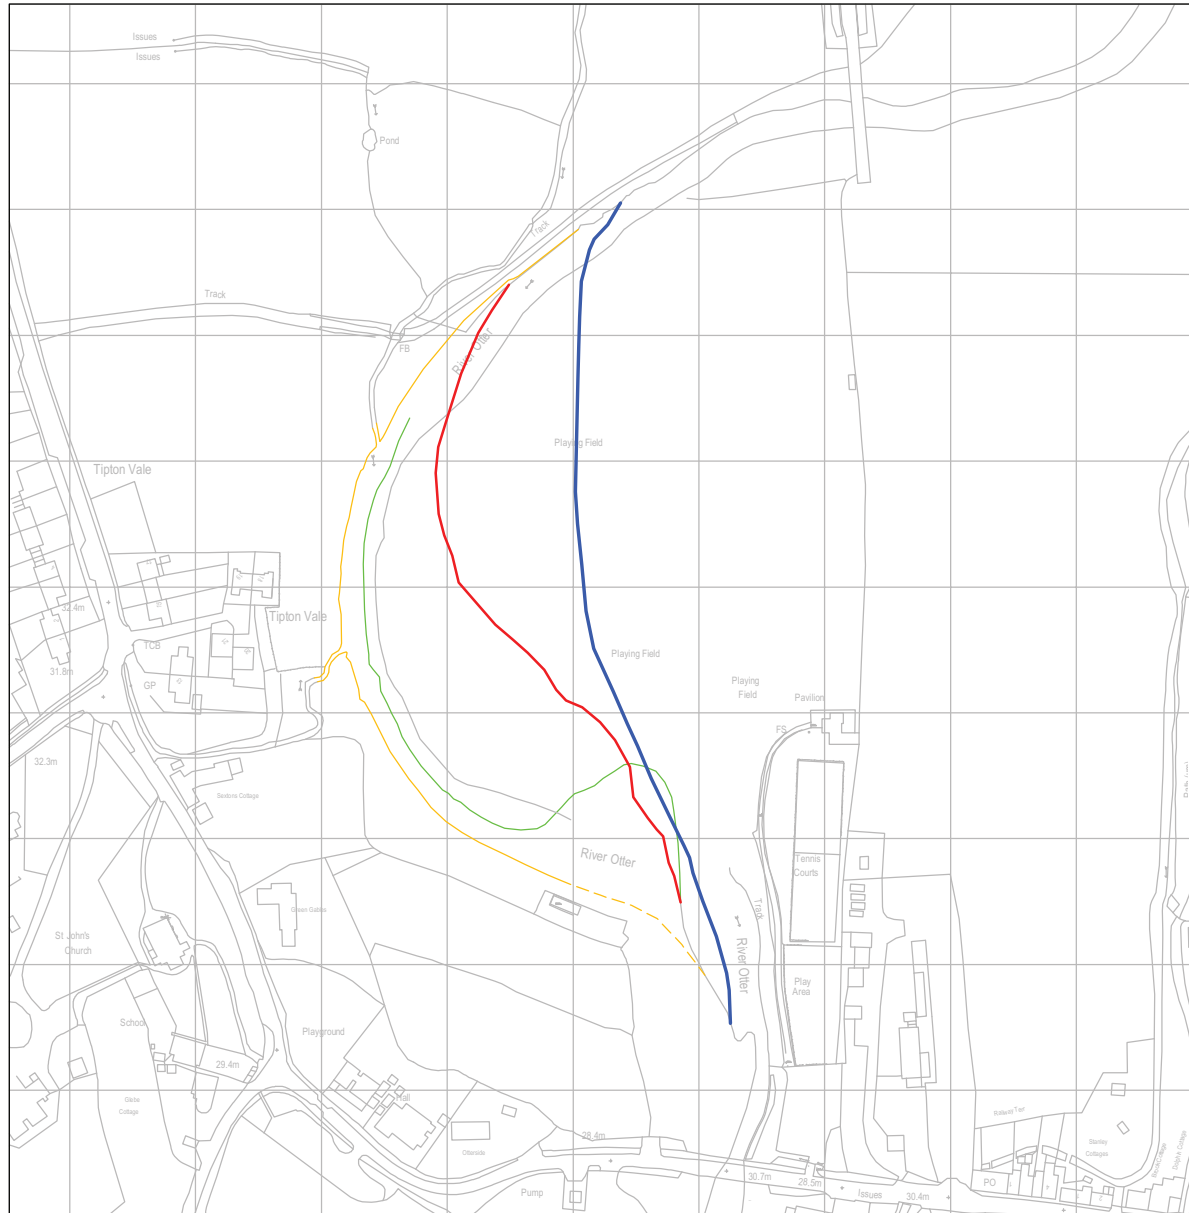
- OS Data 1887 - 1912
- OS Data 1952 - 1990
- OS Data most recent
- Survey 2009
- - - Assumed
- Most recent OS mapping

Rev	Detail	By	Check	Date	
Issued for the purpose indicated above				Approved	Date
Drawn	Checked	Approved			
KGD					
Date	Date	Date			
Sept. 2009					
CLIENT					
East Devon District Council					
JOB					
Tipton Vale River Erosion					
TITLE					
Historic Right Bank Outlines

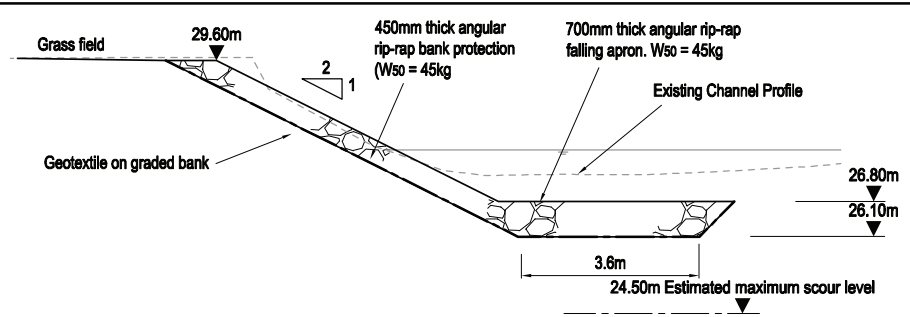
Section A-A (Option 1 - Riprap)
(Scale 1:100)

- 3) It is recommended that bank protection is used to prevent further erosion and that this should be primarily in the form of a rip-rap laid on a stable bank (at a slope of 1 in 2) and that a falling apron should be used to protect the bank face of scour holes at the tow of the bank.

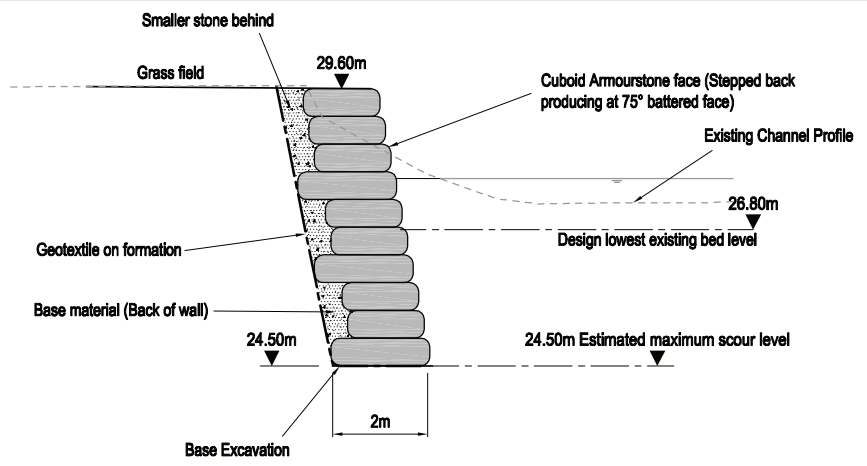
Section A-A (Option 2 - Armourstone Wall)
(Scale 1:100)

The wall would be designed as a gravity structure and would comprise cuboid armourstone dry bedded in layers to form a stable structure. The proposed design is shown as Option 2 on drawing 8041/05 in Appendix A. It would be founded at the scour level of 24.50m AOD and would need to be 2.0m thick to maintain its stability. Cuboid armourstone would have to be used to ensure that each stone is soundly bedded on the ones underneath. There would be no material between each stone; they would rely on friction to keep them in place. Smaller stones and soil would be introduced to fill voids and encourage plants to grow. The size of the armourstone is not critical but to give an acceptable appearance they would have to be reasonably large (at least 500kg).

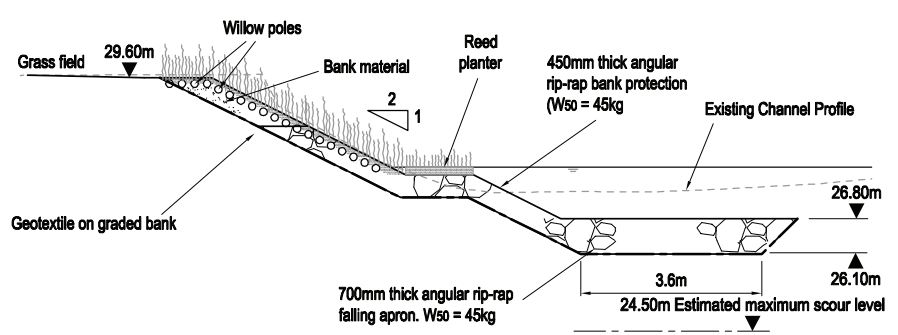
Section A-A (Alternative)
(Scale 1:100)
